**Flood Control Project Maintenance  
Levee Inspections**

**Fall 2011 Levee Maintenance Deficiency Summary Report**

**Sacramento River Basin**

**Reclamation District No. 0150 Merrit Island**

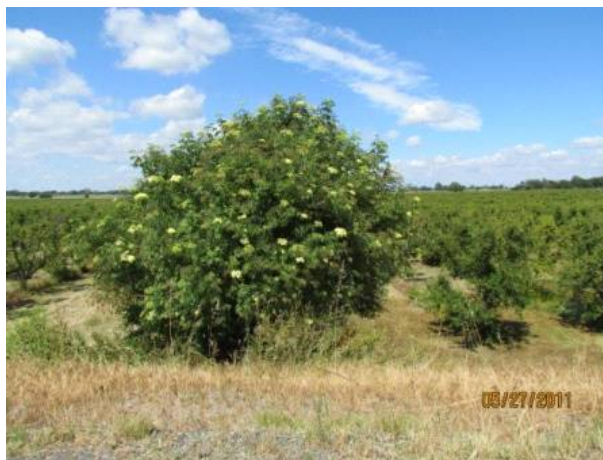
Elderberry tree was found on the landside of the levee. The picture was taken from the crown looking downstream.

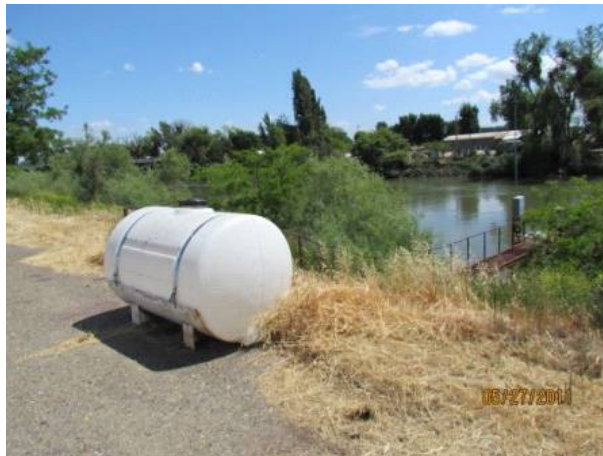
Levee Mile Report Line	3
Start Levee Mile	0.35
End Levee Mile	0.35
Location	Water Side
Category	Earthen Levee
Item	Encroachments

A water tank was found on the waterside of the levee. The picture was taken from the crown looking downstream.

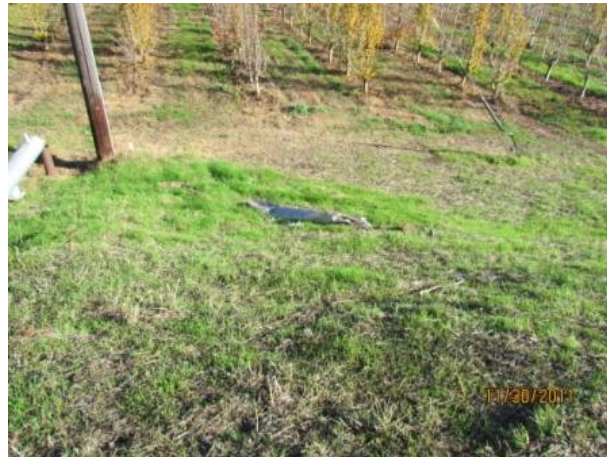
Levee Mile Report Line	5
Start Levee Mile	0.46
End Levee Mile	0.46
Location	Land Side
Category	Earthen Levee
Item	Encroachments

Debris was found on the landside of the levee looking upstream.

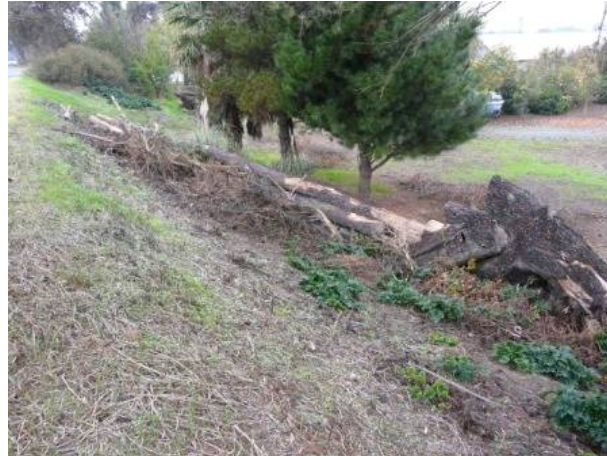
Levee Mile Report Line	6
Start Levee Mile	0.27
End Levee Mile	0.27
Location	Land Side
Category	Earthen Levee
Item	Encroachments
Remove tree branches from landside of levee at LM 0.27	
pkazi_f_20110923_309.JPG

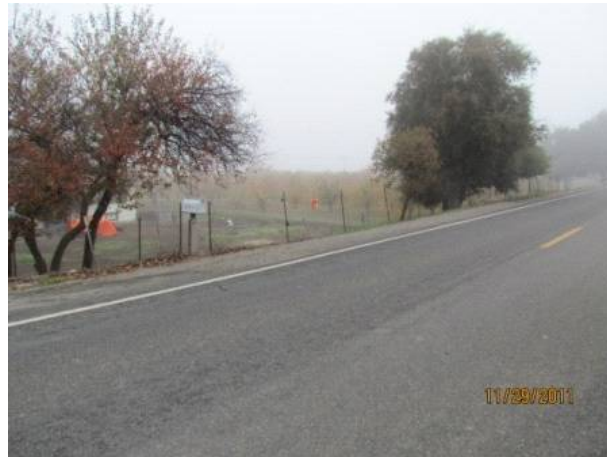
Levee Mile Report Line	7
Start Levee Mile	0.34
End Levee Mile	0.34
Location	Land Side
Category	Earthen Levee
Item	Encroachments
Fence was found on the landside of the levee looking upstream.	
pkazi_f_20111208_435.jpg

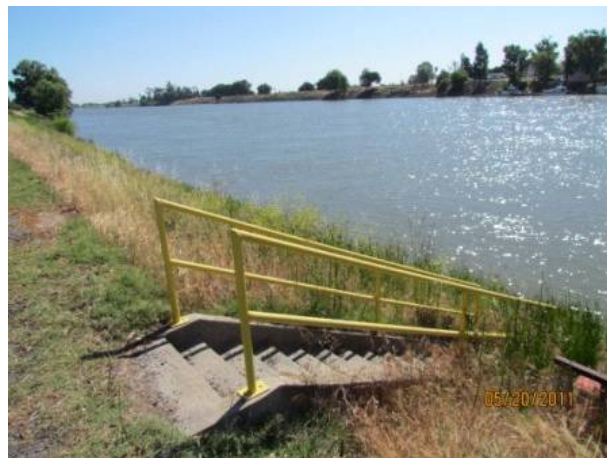
Levee Mile Report Line	8
Start Levee Mile	0.39
End Levee Mile	0.39
Location	Water Side
Category	Earthen Levee
Item	Encroachments
A stairway was found on the waterside of the levee. The picture was taken from the crown looking upstream.	
pkazi_f_20110923_281.jpg

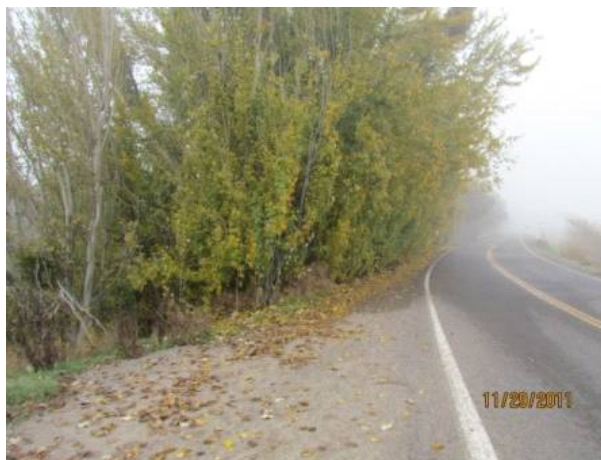
Landscaping was found landside of the levee looking upstream.

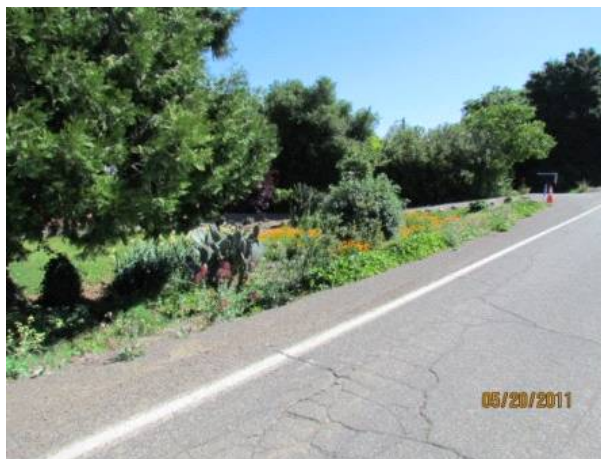
Levee Mile Report Line	27
Start Levee Mile	2.31
End Levee Mile	2.33
Location	Land Side
Category	Earthen Levee
Item	Encroachments

Landscaping was found on the landside of the levee. The picture was taken from the crown looking upstream.

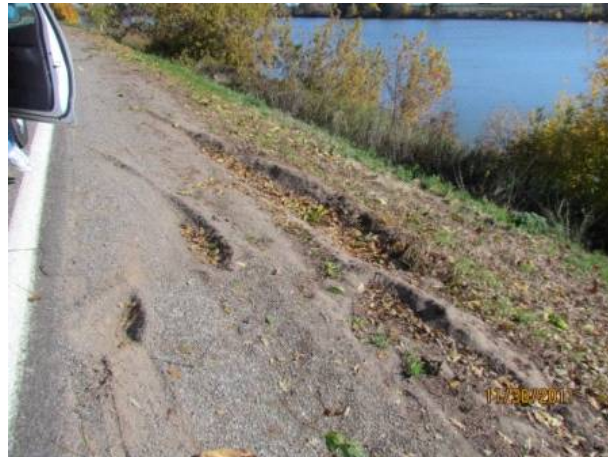
Levee Mile Report Line	32
Start Levee Mile	2.82
End Levee Mile	2.82
Location	Water Side
Category	Earthen Levee
Item	Slope Stability

Slope instability was found on the waterside slope of the levee looking upstream.

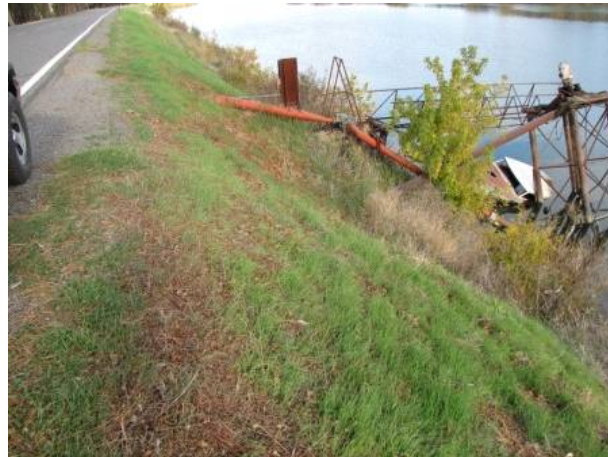
Levee Mile Report Line	36
Start Levee Mile	3.29
End Levee Mile	3.29
Location	Water Side
Category	Earthen Levee
Item	Erosion / Bank Caving

Additional view of erosion on the waterward slope looking upstream. Note the damaged pump support, pump, and pipe just upstream of the site.

LMR No.	Levee Mile		Category	Item	Location	Rating	Action/Comment	GPS Latitude/Longitude		Issue No. Photo
	Start	End						Start	End	
36	3.29	3.29	Earthen Levee	Erosion / Bank Caving	WS	M	Schedule repair of erosion site prior to the next inspection. Inspector Comments: Depressions into the waterward slope can be seen along the waterward slope at this site. Also note the damaged pump support, pump, and pipe just upstream of the site; they may contribute to the erosion in a high water event and should be removed.	38.355321 ° -121.530902 °	38.355321 ° -121.530902 °	961 Y
37	3.31	3.31	Earthen Levee	Trim / Thin Trees	LS	A	Thin trees to allow visibility of the ground and room to flood fight.	38.355632 ° -121.530740 °	38.355632 ° -121.530740 °	952 Y
38	3.35	3.35	Earthen Levee	Vegetation	LS	M	Elderberries are blocking visibility and flood fight capability.	38.355979 ° -121.530288 °	38.355979 ° -121.530288 °	17

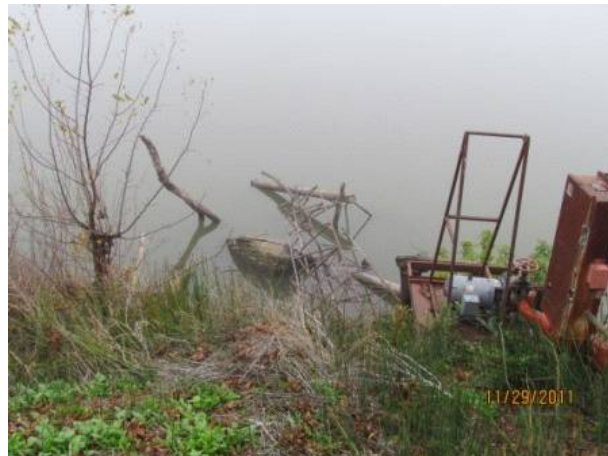
Levee Mile Report Line	36
Start Levee Mile	3.29
End Levee Mile	3.29
Location	Water Side
Category	Earthen Levee
Item	Erosion / Bank Caving

View of the erosion site, and broken pump support along with a boat on the waterside of the levee. The picture was taken from the crown looking towards the toe of the levee during fall 2011 inspection.

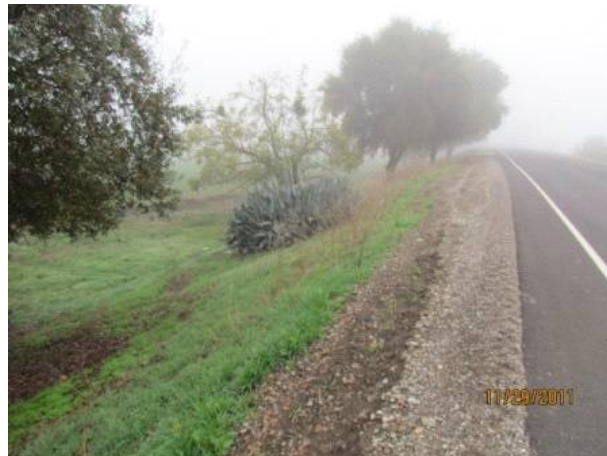
Levee Mile Report Line	67
Start Levee Mile	6.41
End Levee Mile	6.41
Location	Land Side
Category	Earthen Levee
Item	Encroachments

Century plant was found on the landside of the levee looking upstream.

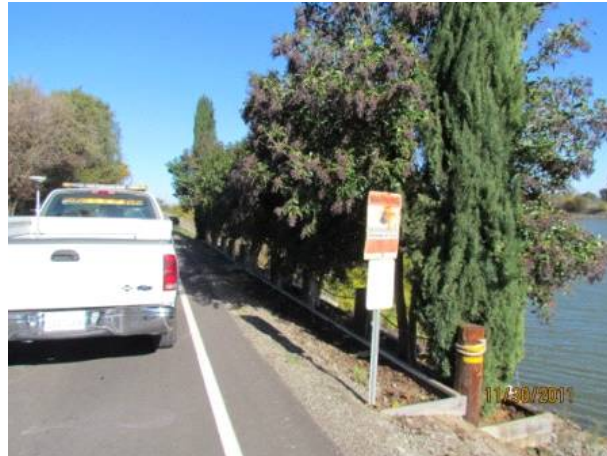
Levee Mile Report Line	73
Start Levee Mile	6.53
End Levee Mile	6.53
Location	Water Side
Category	Earthen Levee
Item	Encroachments

Landscaping was found on the waterside of the levee looking upstream.

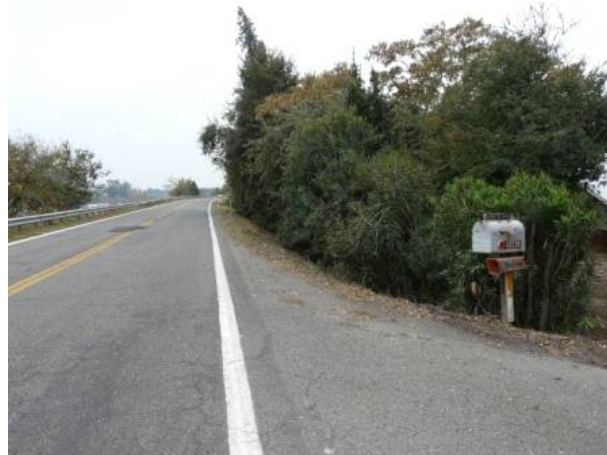
Levee Mile Report Line	79
Start Levee Mile	6.93
End Levee Mile	7.05
Location	Land Side
Category	Earthen Levee
Item	Encroachments
Landscaping providing a screen for a residence on landside of levee from LM 6.93 to LM 7.05	
pkazi_f_20110923_301.JPG

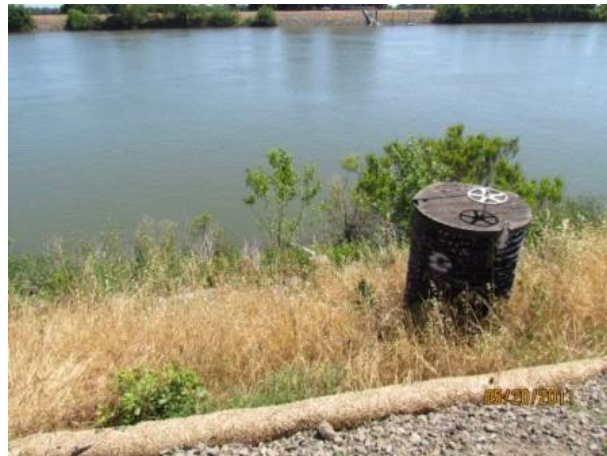
Levee Mile Report Line	80
Start Levee Mile	7.12
End Levee Mile	7.12
Location	Water Side
Category	Earthen Levee
Item	Encroachments
No debris was found near the gate where debris was found during last inspection. The picture was taken from the crown looking waterside of the levee.	
pkazi_f_20110923_298.jpg

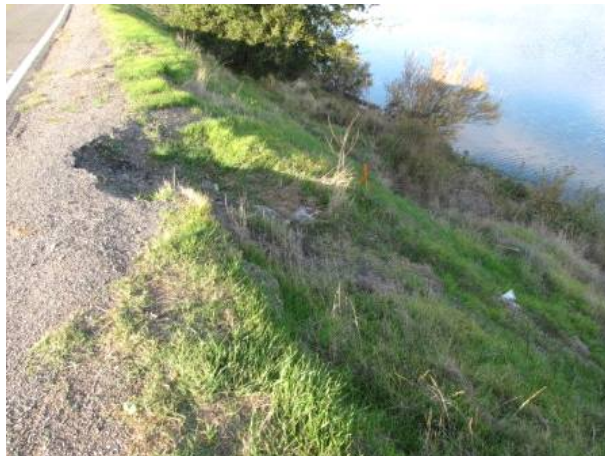
Levee Mile Report Line	83
Start Levee Mile	7.28
End Levee Mile	7.28
Location	Water Side
Category	Earthen Levee
Item	Slope Stability

View of minor erosion along the top portion of the waterward slope likely cause by foot traffic. The erosion has started to encroach into the shoulder of the road.

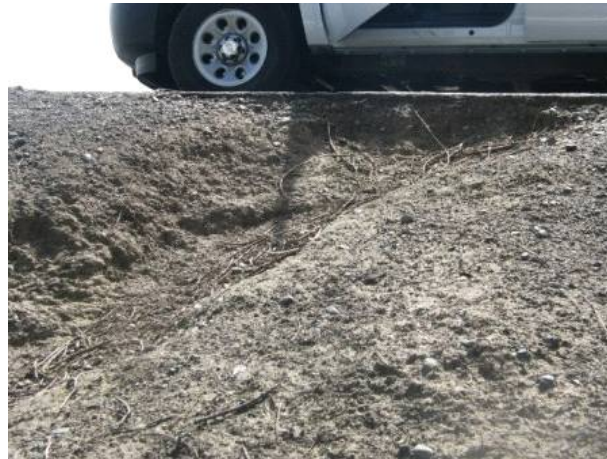
Levee Mile Report Line	8
Start Levee Mile	1.23
End Levee Mile	1.23
Location	Land Side
Category	Earthen Levee
Item	Slope Stability

Damaged slope from foot traffic and rain runoff at LM 1.23

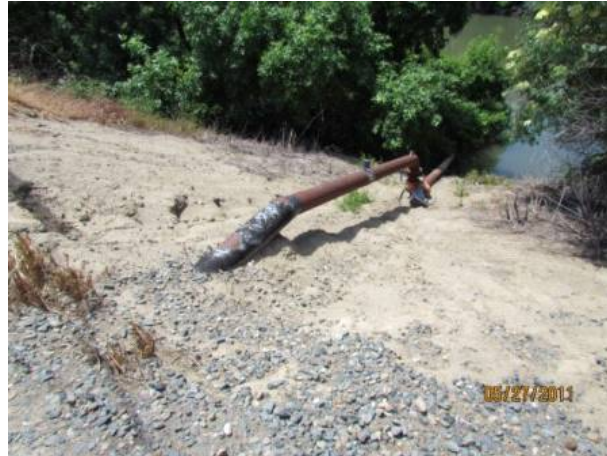
Erosion was found on the waterside slope of the levee near the vicinity of the pipe. The picture was taken from the crown looking downstream.

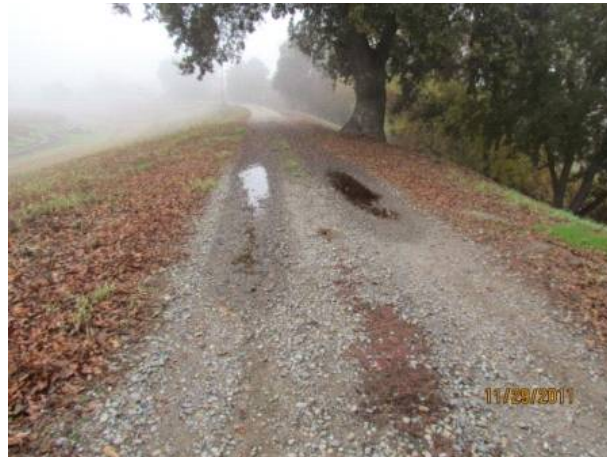
Levee Mile Report Line	11
Start Levee Mile	1.87
End Levee Mile	1.87
Location	Crown
Category	Earthen Levee
Item	Crown Surface / Depressions / Rutting

Depression was found on the crown of the levee looking downstream.

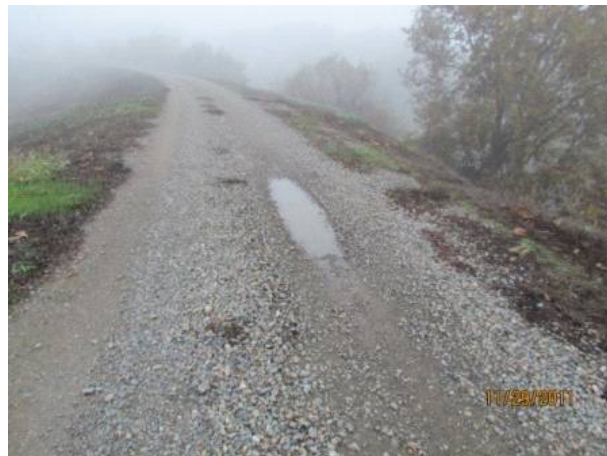
Levee Mile Report Line	13
Start Levee Mile	2.07
End Levee Mile	2.07
Location	Crown
Category	Earthen Levee
Item	Crown Surface / Depressions / Rutting

Depression was found on the crown of the levee looking downstream.

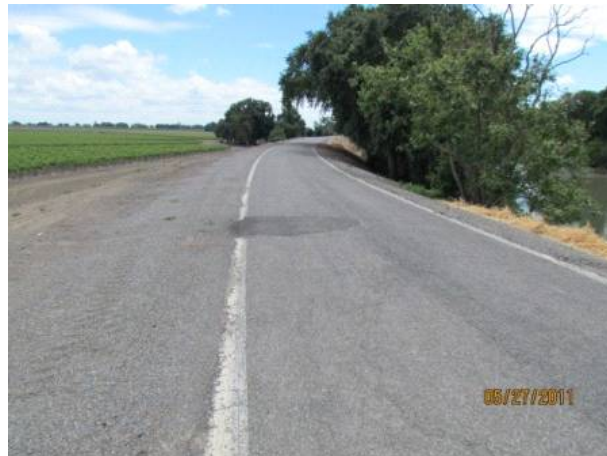
Levee Mile Report Line	16
Start Levee Mile	2.77
End Levee Mile	2.77
Location	Crown
Category	Earthen Levee
Item	Crown Surface / Depressions / Rutting

The crown was repaired by the LMA. The picture was taken from the crown looking downstream.

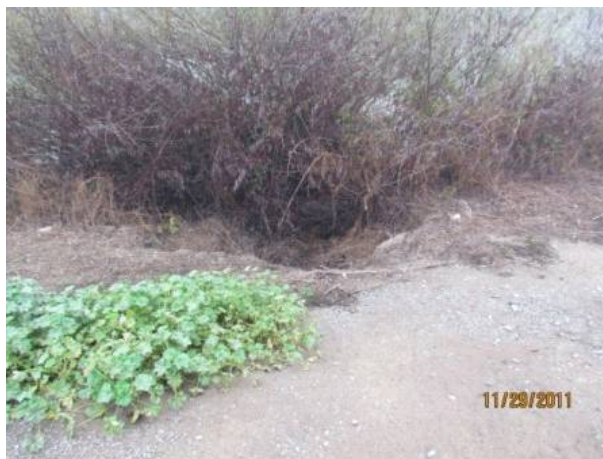
Levee Mile Report Line	18
Start Levee Mile	2.93
End Levee Mile	2.93
Location	Water Side
Category	Earthen Levee
Item	Slope Stability

Slope instability was found on the waterside of the levee. The picture was taken from the crown looking towards the toe of the levee.

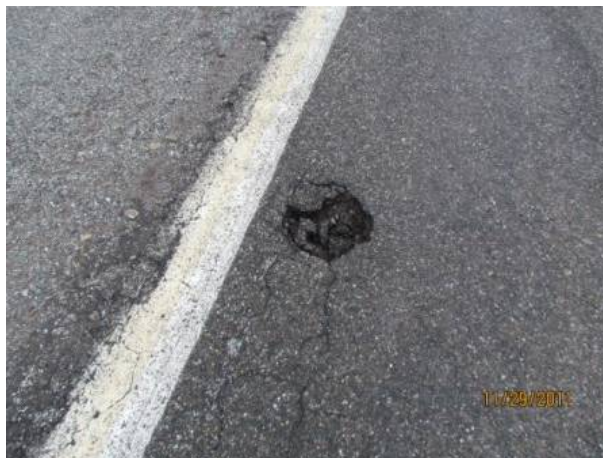
Levee Mile Report Line	19
Start Levee Mile	2.93
End Levee Mile	2.93
Location	Crown
Category	Earthen Levee
Item	Crown Surface / Depressions / Rutting

Depression was found on the crown of the levee looking downstream.

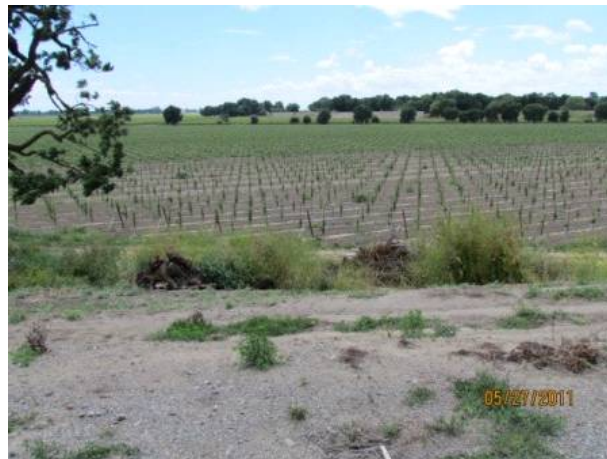
Levee Mile Report Line	24
Start Levee Mile	3.30
End Levee Mile	3.30
Location	Land Side
Category	Earthen Levee
Item	Encroachments

Debris were found on the landside of the levee. The picture was taken from the crown looking landside.

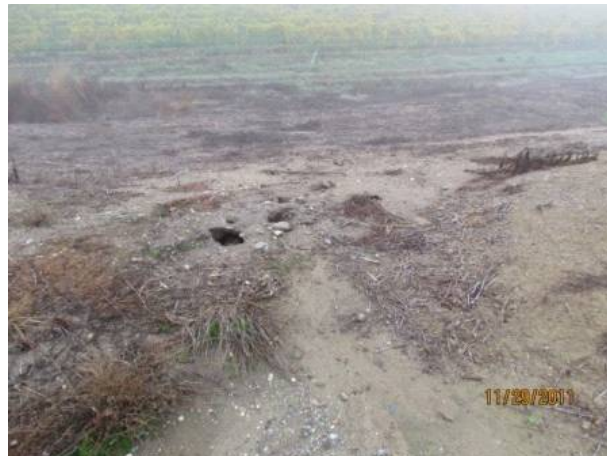
Levee Mile Report Line	25
Start Levee Mile	3.34
End Levee Mile	3.34
Location	Land Side
Category	Earthen Levee
Item	Animal Control

Rodent holes were found on the landside of the levee looking downstream.

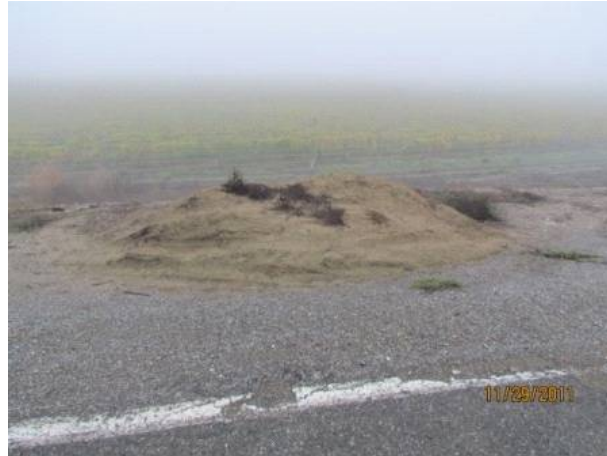
Levee Mile Report Line	26
Start Levee Mile	3.34
End Levee Mile	3.34
Location	Land Side
Category	Earthen Levee
Item	Encroachments
Material was found on the landside of the levee looking downstream.	
pkazi_f_20111208_429.jpg

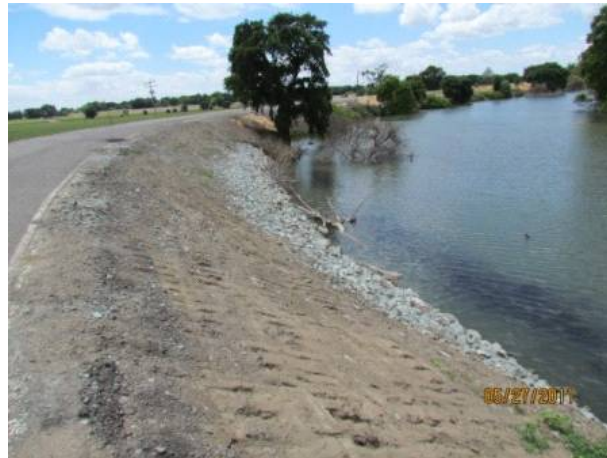
The erosion site has been repaired by LMA. The picture was taken from the crown looking downstream.

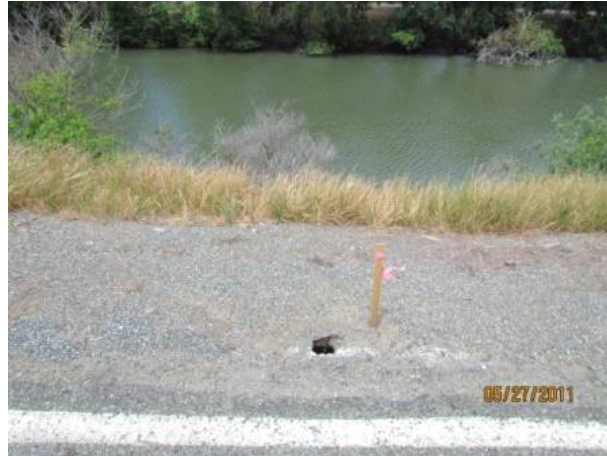
A rodent hole was found on the shoulder of waterside of the levee. The picture was taken from the crown looking toward the slough.

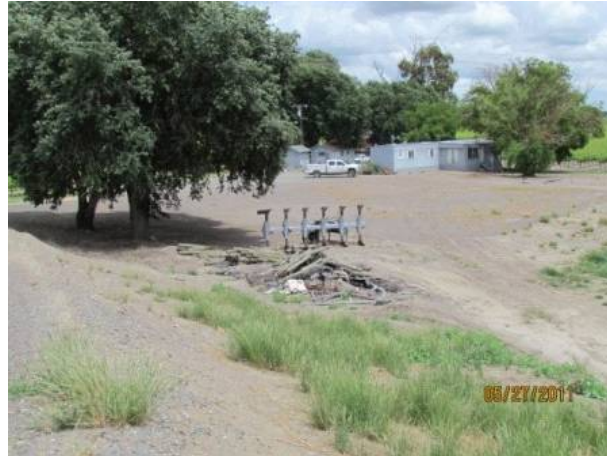
Debris found on the landside of the levee during Spring 2011 inspection. The picture was taken from the crown looking upstream.

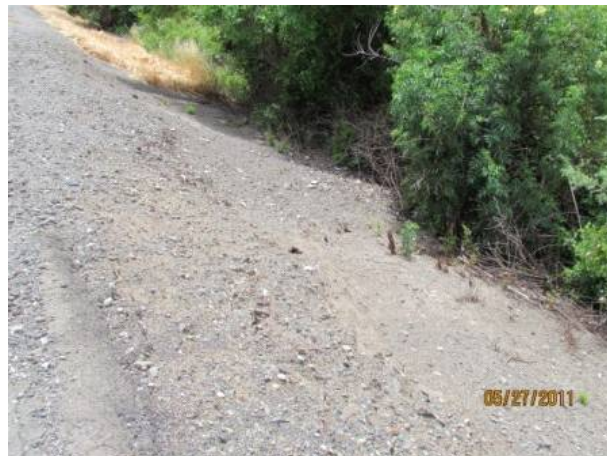
Levee Mile Report Line	37
Start Levee Mile	4.10
End Levee Mile	4.10
Location	Water Side
Category	Earthen Levee
Item	Animal Control

A rodent hole was found on the waterside slope of the levee. The picture was taken from the crown looking downstream.

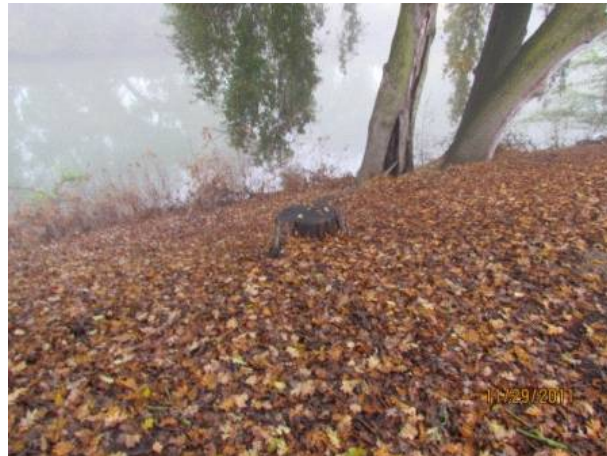
Levee Mile Report Line	49
Start Levee Mile	5.66
End Levee Mile	5.66
Location	Water Side
Category	Earthen Levee
Item	Trim / Thin Trees

Tree stump was found on the waterside of the levee looking upstream.

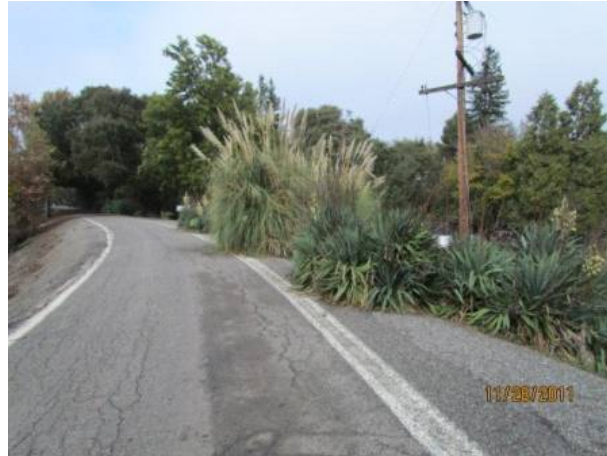
Levee Mile Report Line	54
Start Levee Mile	6.01
End Levee Mile	6.09
Location	Land Side
Category	Earthen Levee
Item	Encroachments
Landscaping was found on the landside of the levee looking upstream.	
pkazi_f_20111208_418.jpg

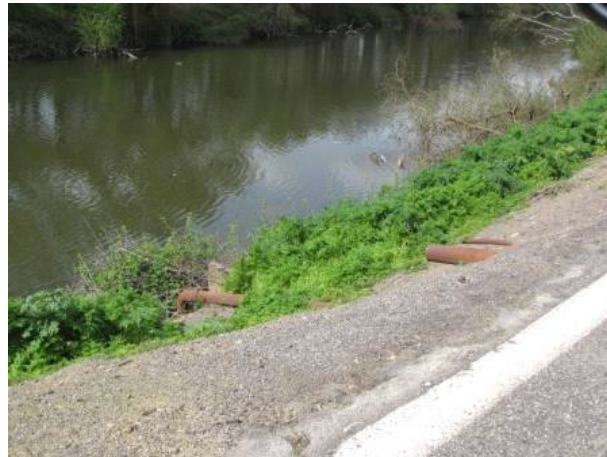
Levee Mile Report Line	55
Start Levee Mile	6.06
End Levee Mile	6.06
Location	Water Side
Category	Earthen Levee
Item	Encroachments
View of an improperly abandoned pipe through the levee looking upstream.	
pkazi_f_20110923_355.jpg

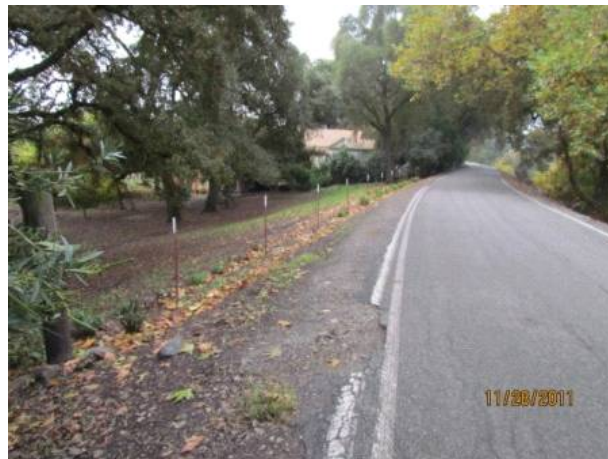
Levee Mile Report Line	64
Start Levee Mile	6.93
End Levee Mile	6.95
Location	Land Side
Category	Earthen Levee
Item	Encroachments
Fence was found on the landside of the levee looking downstream.	
pkazi_f_20111208_419.jpg

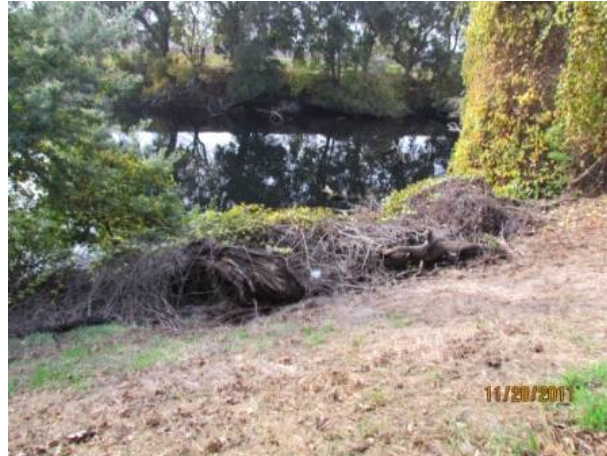
Levee Mile Report Line	71
Start Levee Mile	7.47
End Levee Mile	7.47
Location	Water Side
Category	Earthen Levee
Item	Encroachments
Debris was found on the waterside of the levee looking upstream.	
pkazi_f_20111208_421.jpg

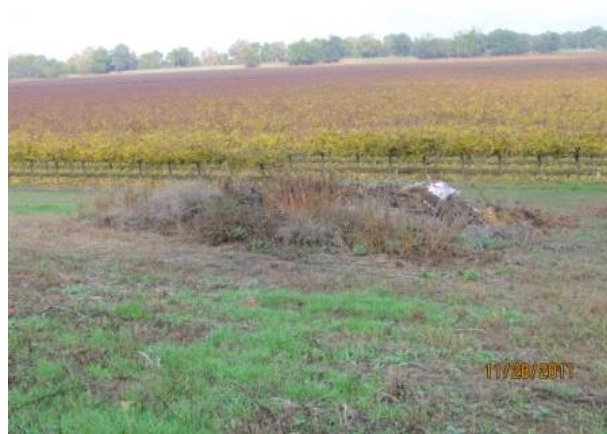
Levee Mile Report Line	75
Start Levee Mile	7.60
End Levee Mile	7.60
Location	Land Side
Category	Earthen Levee
Item	Encroachments

Prunings were found on the landside of the levee looking upstream. This picture was taken during fall 2011 inspection.

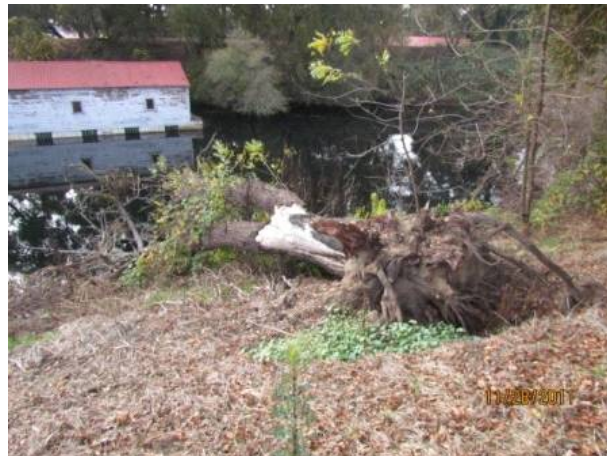
Levee Mile Report Line	77
Start Levee Mile	7.82
End Levee Mile	7.82
Location	Water Side
Category	Earthen Levee
Item	Encroachments

Tree limb was found on the waterside of the levee looking upstream.

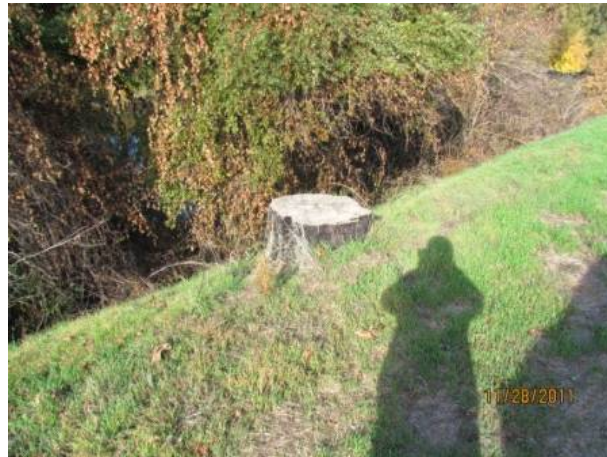
Levee Mile Report Line	84
Start Levee Mile	8.65
End Levee Mile	8.65
Location	Water Side
Category	Earthen Levee
Item	Trim / Thin Trees

A tree stump was found on the waterside of the levee looking upstream.
